Submitted in Partial Satisfaction of the Requirements for  
the Degree of Master of Engineering

REPAIRS TO CONCRETE  
PORT AND HARBOR STRUCTURES

MAX D. RODGERS  
and  
JAMES M. SCHOFIELD

Hydraulic and Coastal Engineering  
Department of Civil Engineering  
University of California  
Berkeley, California

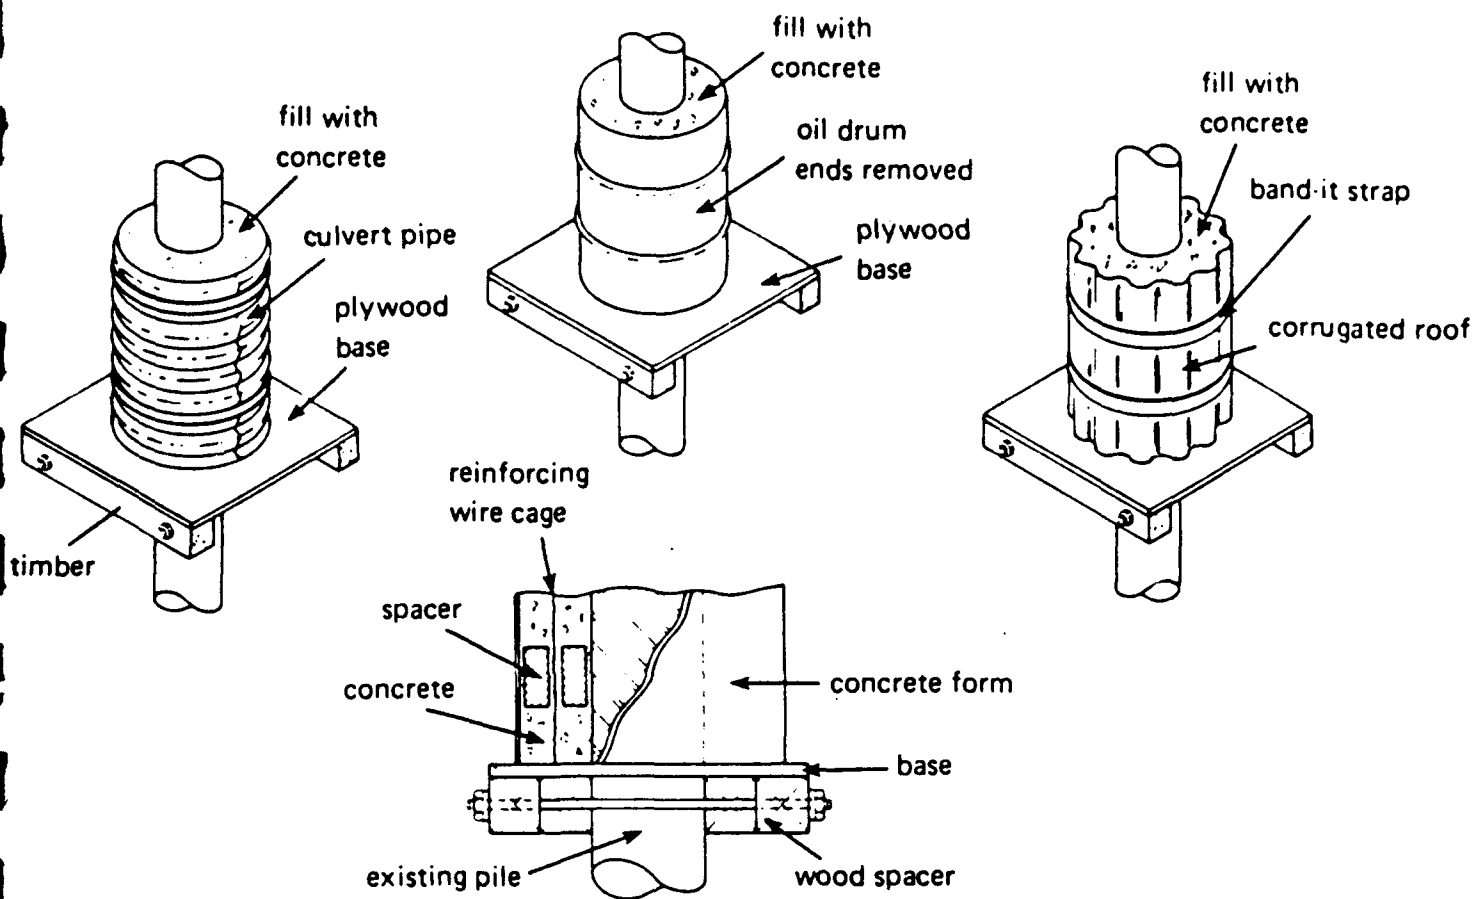
**FIGURE IV.8 Alternative Forming Methods for Concrete Encasement**

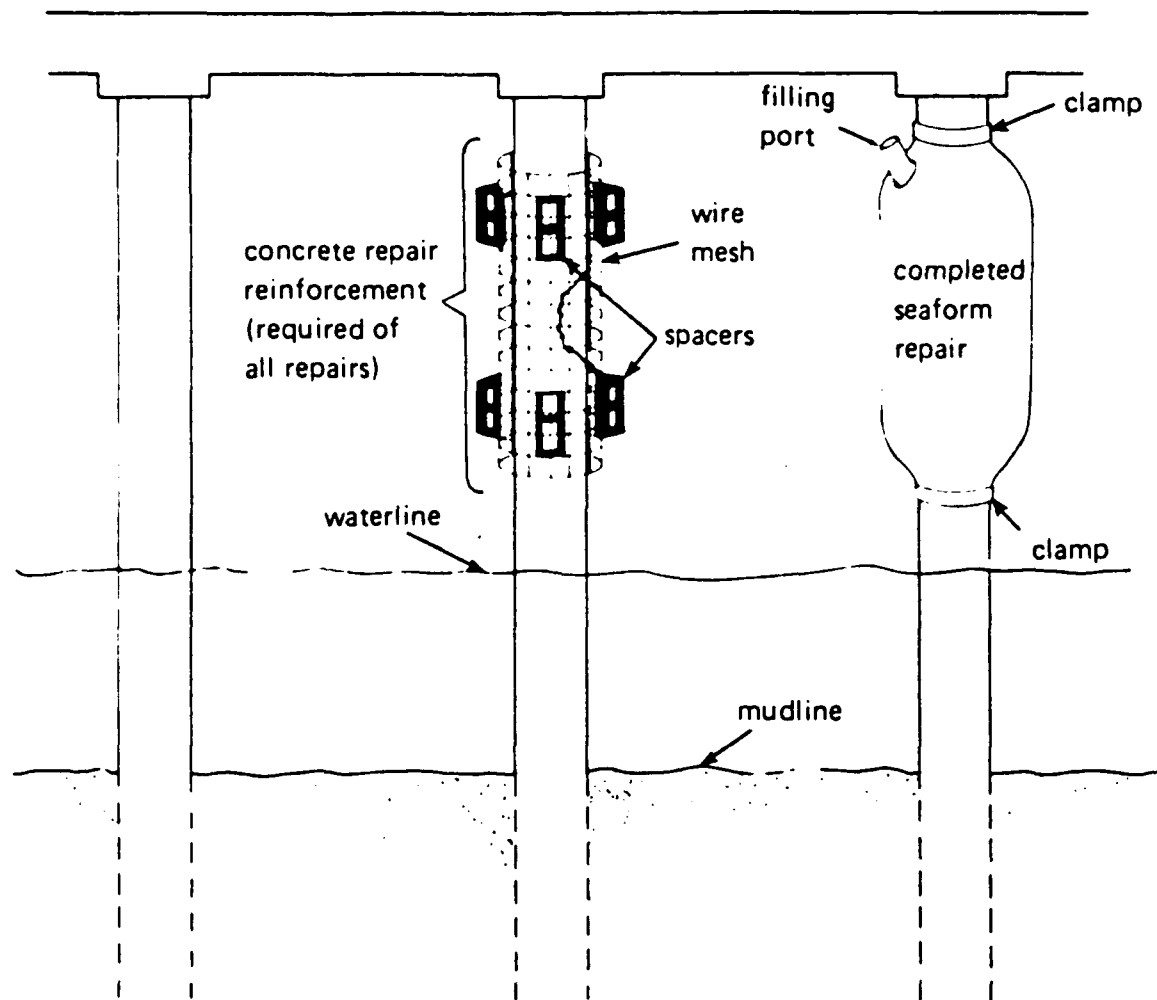
**FIGURE IV.9 "Seaform" Repair Technique for Concrete Encasement**

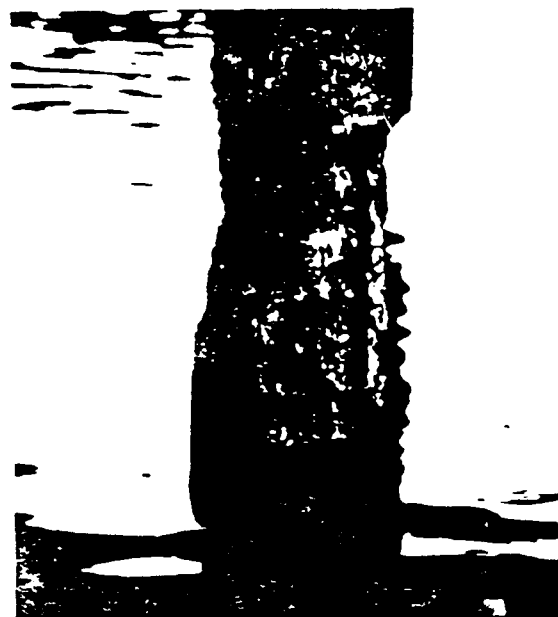
<p style="margin-top: 10px;">Typical condition where Types I and III jacket should be used.</p> </div> </div>

**FIGURE IV.12 Encasement of Concrete Pile Using Fiberglass Form**

Type I, III and V are used when deterioration terminates at the water line or no more than one or two feet below.

Type II, IV and VI are used when deterioration runs the full length of the pile.

Typical condition where Types II and IV jacket should be used.

Typical condition where Types V or VI jacket should be used.

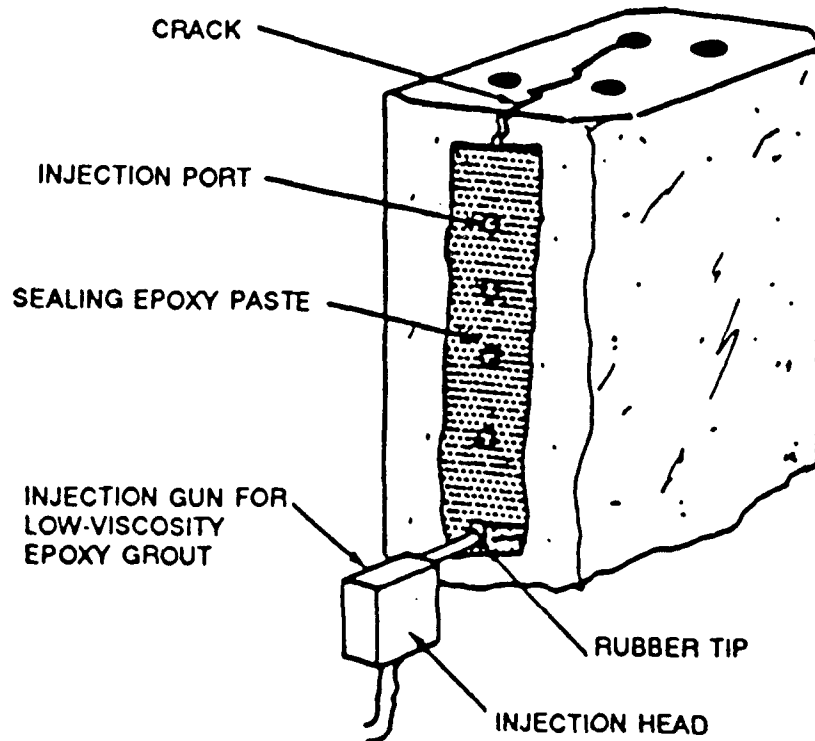
**FIGURE IV.15 Typical Arrangement for Concrete Crack Repair Using  
Epoxy Injection [54]**

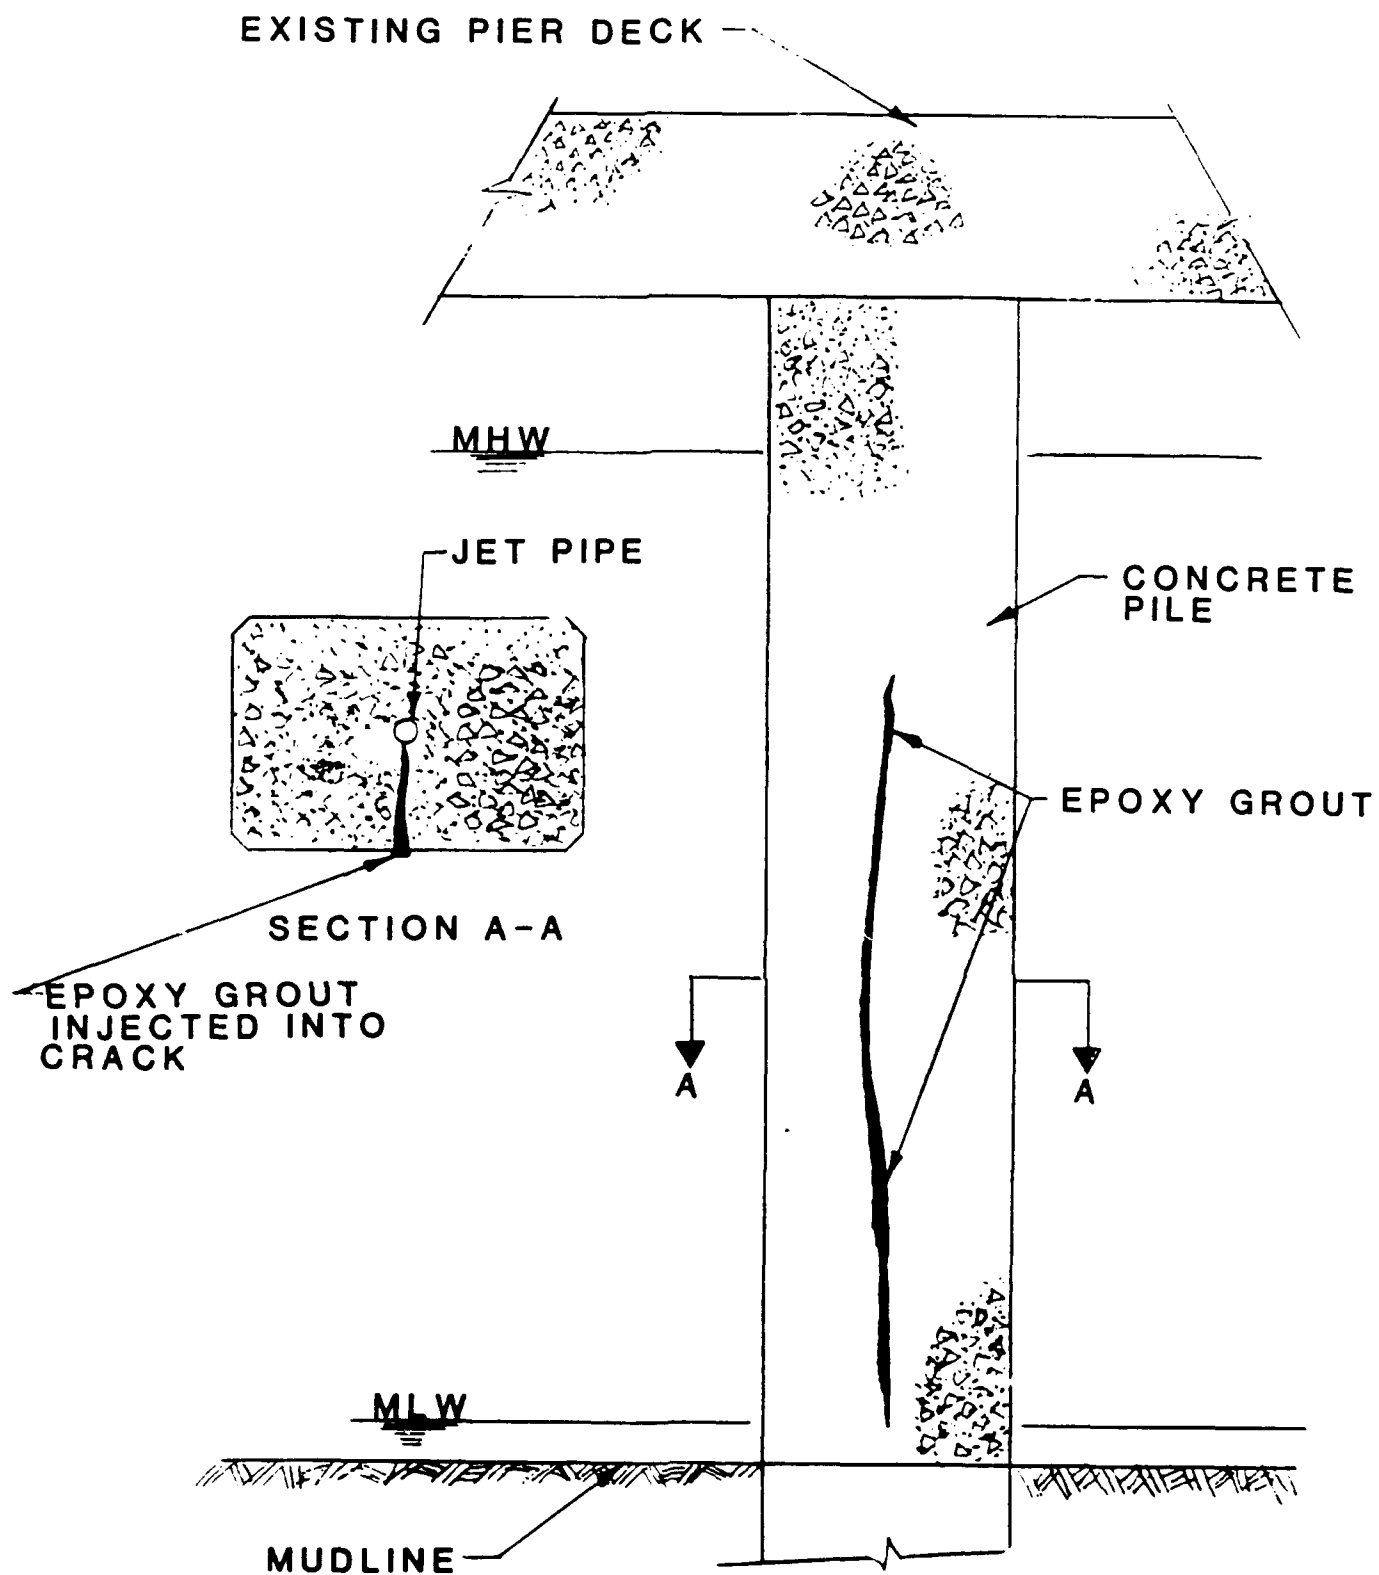
FIGURE IV.16 Epoxy Injection Arrangement For Damaged Concrete

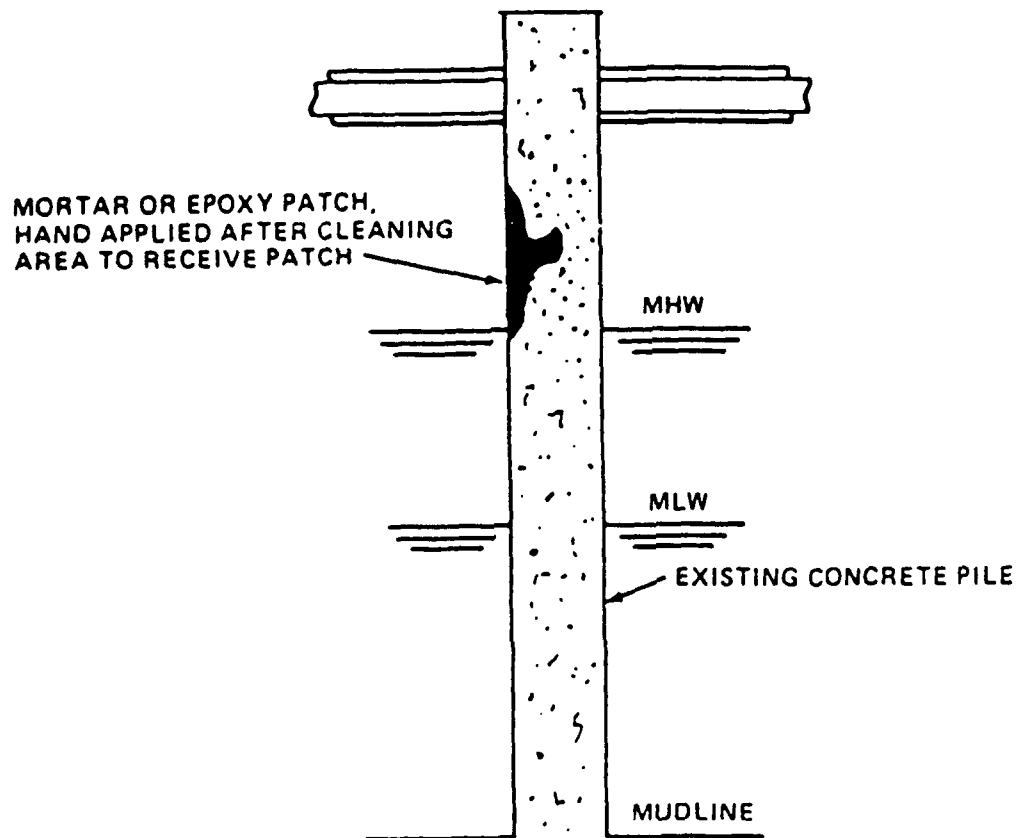
**FIGURE IV.19 Patching Method for Repairing Concrete Piles [61]**

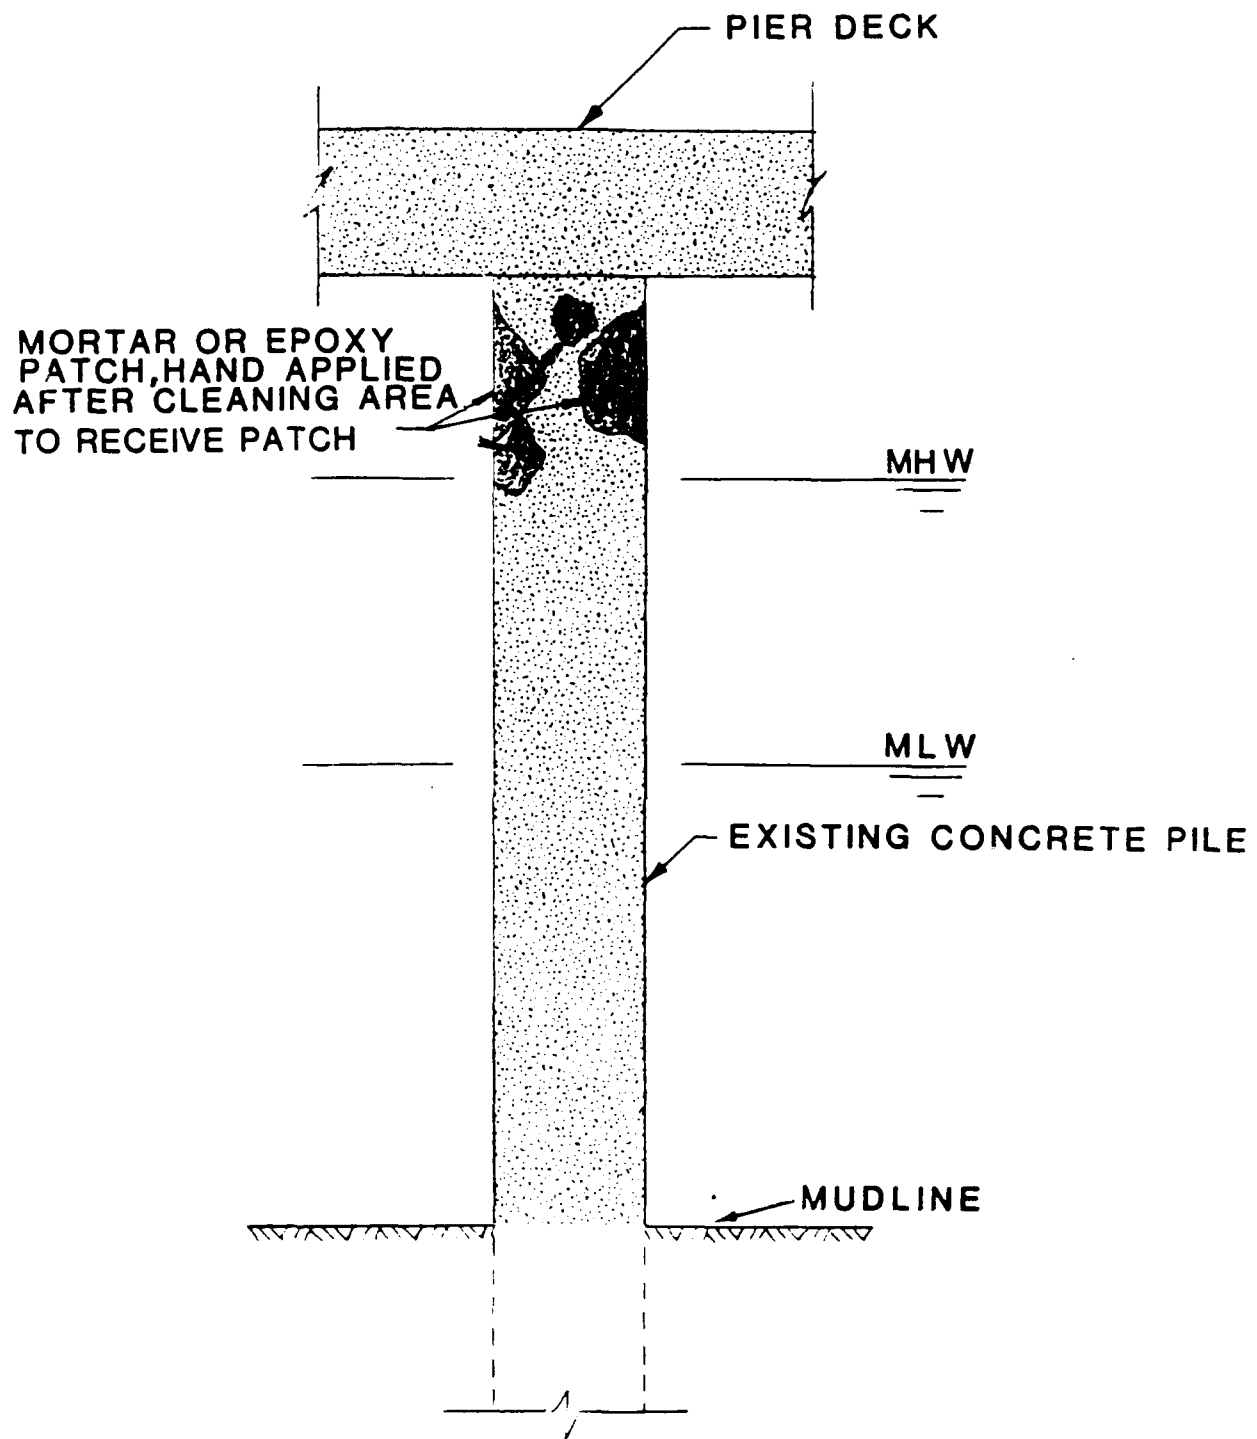
**FIGURE IV.20 Hand Applied Patch Material on Concrete Pier Pile**

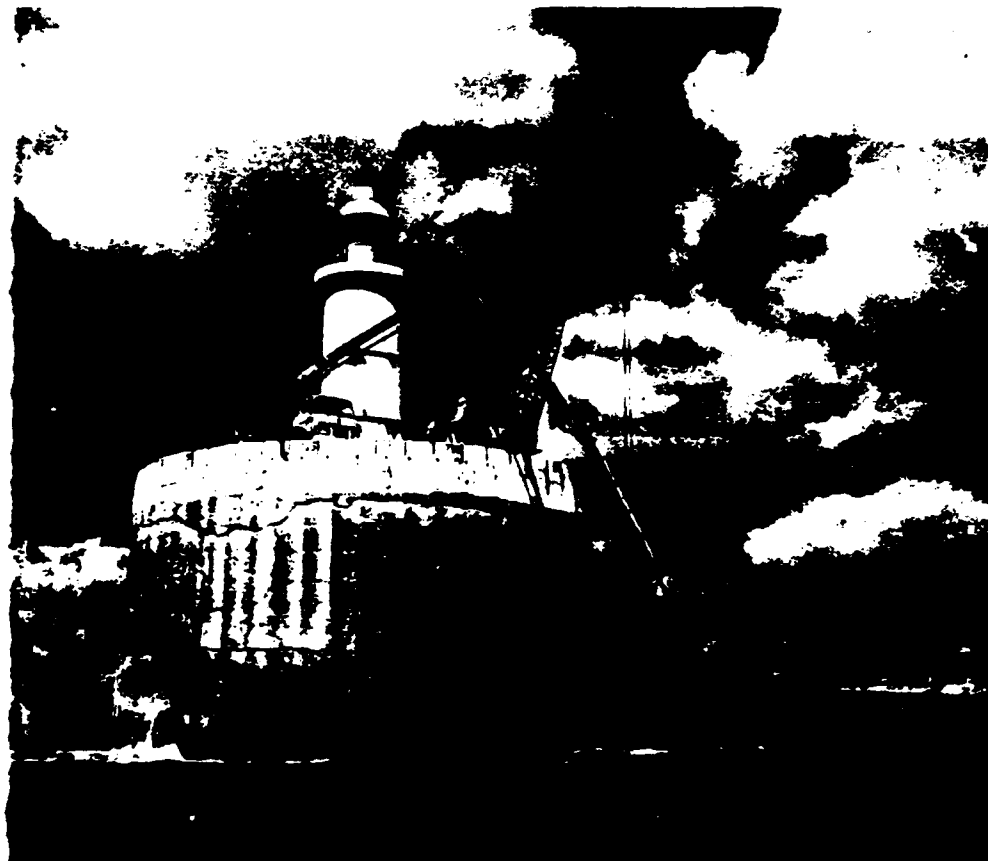
FIGURE IV.25 Pumped Placement of Underwater Concrete at a  
Harbor Entrance [55]

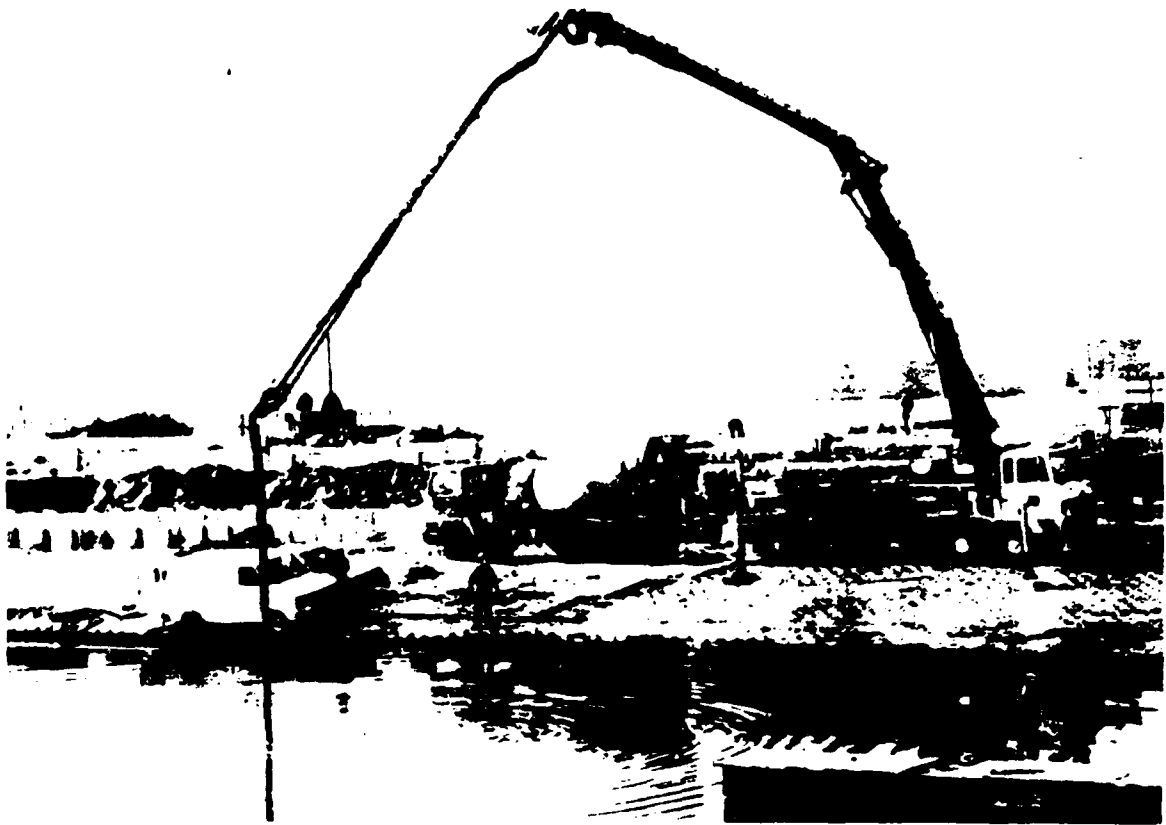
FIGURE IV.26 Example of Using Pumped Tremie Concrete to Access  
an Underwater Repair [55]

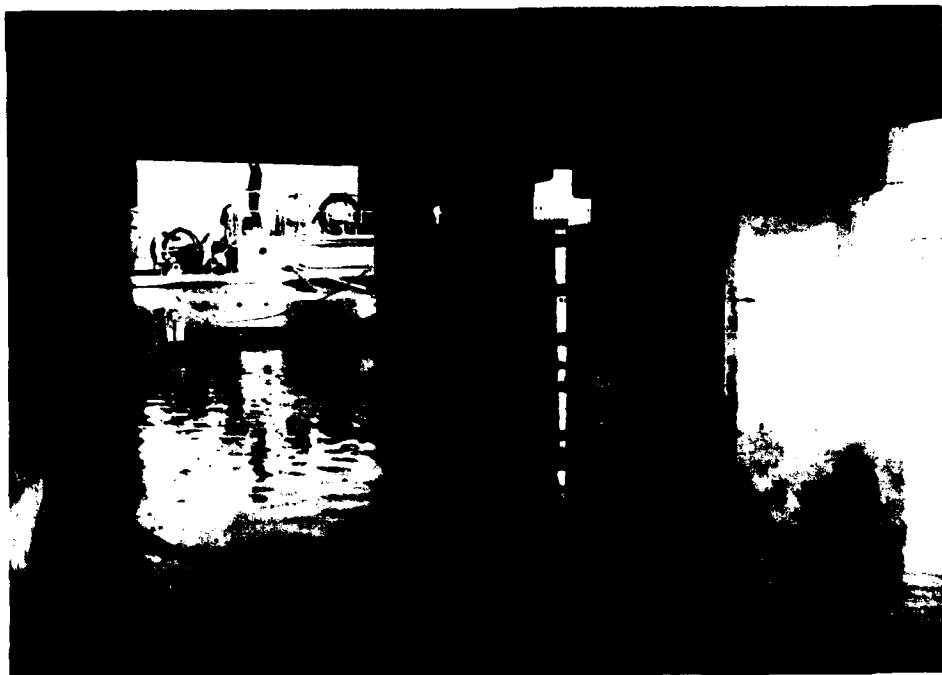
Photo V.10 WWF installed on piles A3, form installed on Piles B3  
and completed repair on piles C3

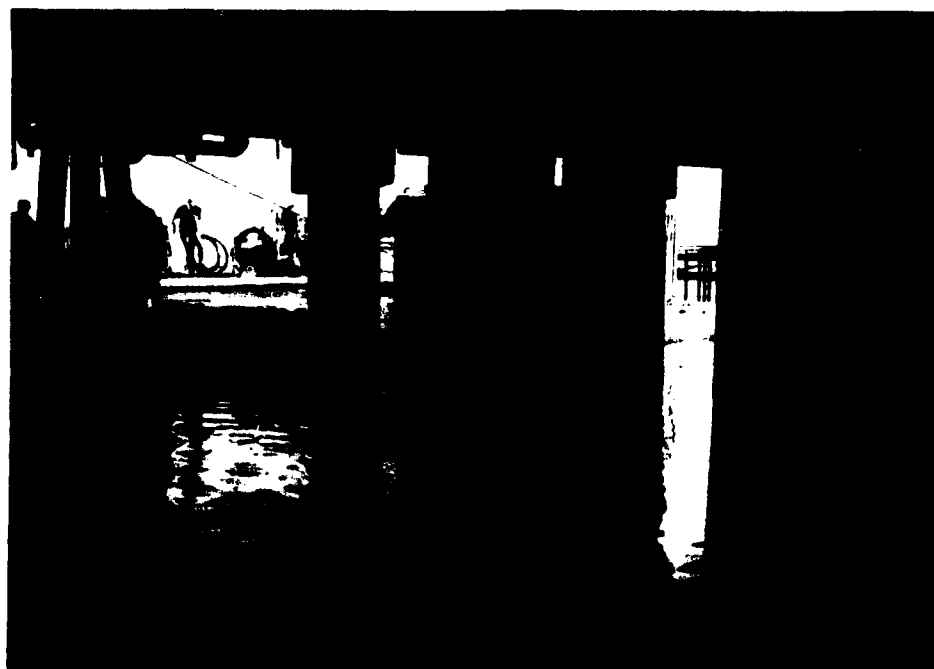
Photo V.16 Completed repairs on piles B2 and C2, WWF installed on  
pile A2

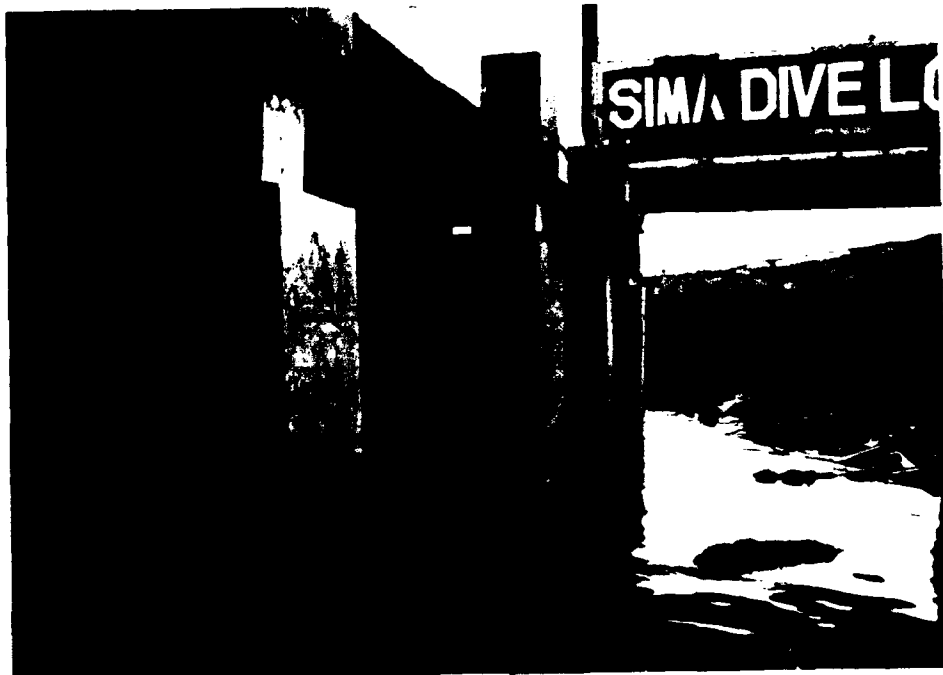
Photo V.17 Completed repairs to piles C1-C4

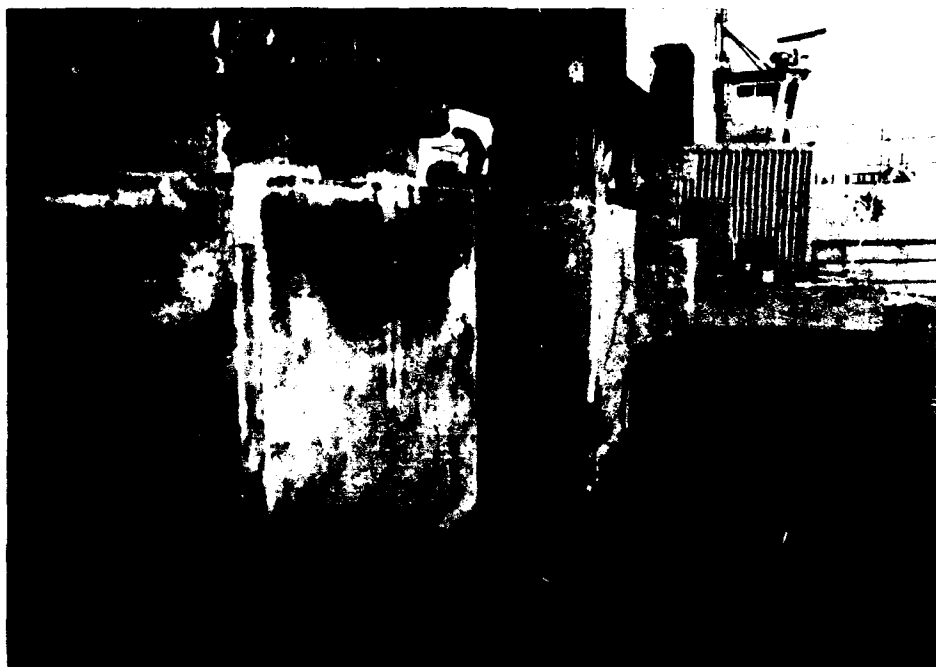
Photo V.18 Completed repairs to piles A4, B4 and C4

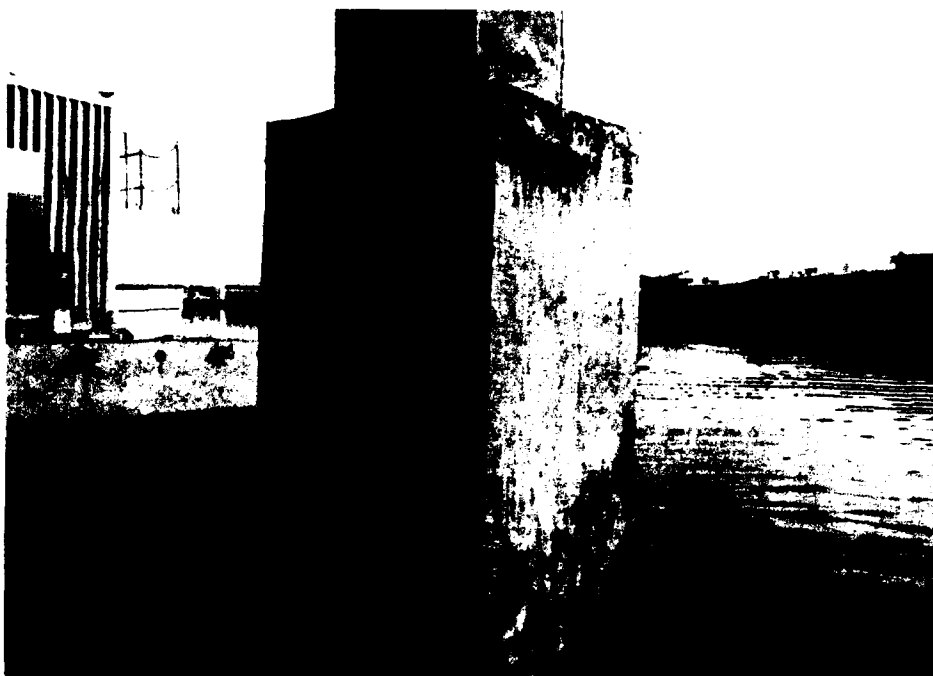
Photo V.19 Completed repair to Pile A4

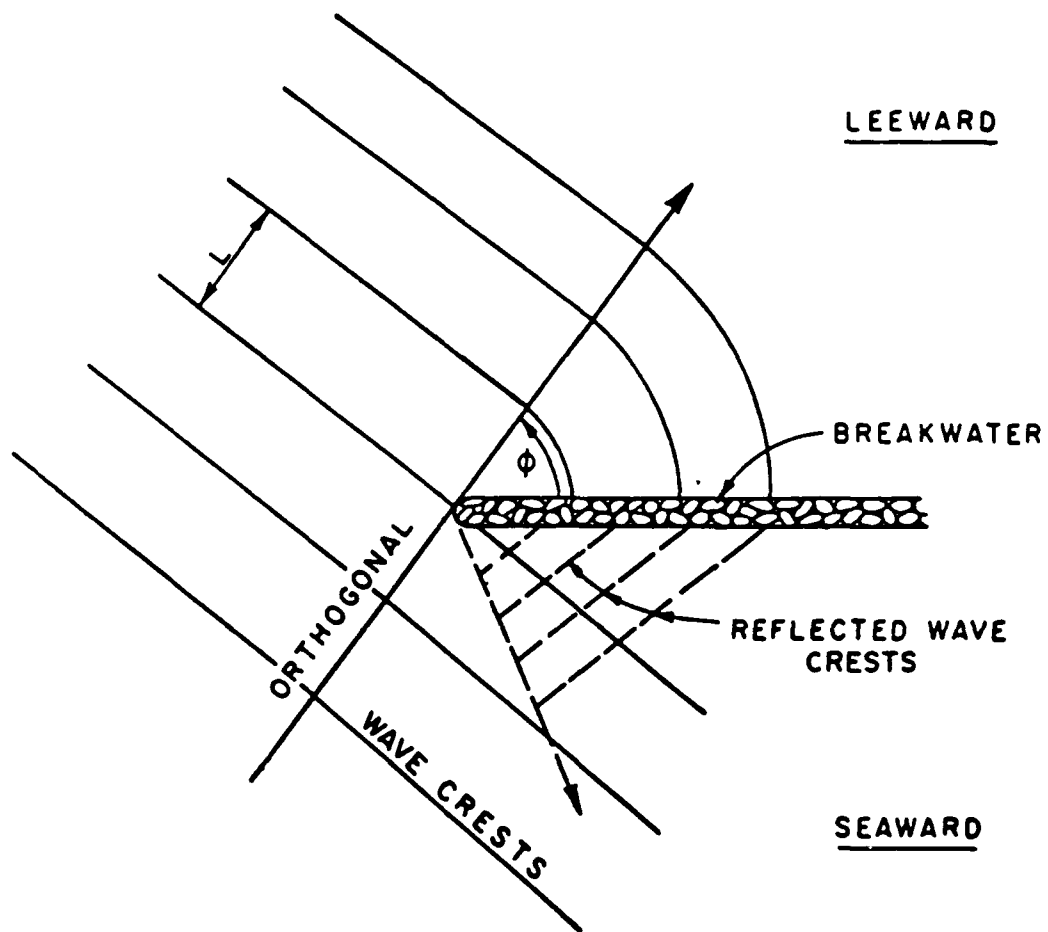
FIGURE (1) Wave Diffraction Around  
a Breakwater [After Wiegel]

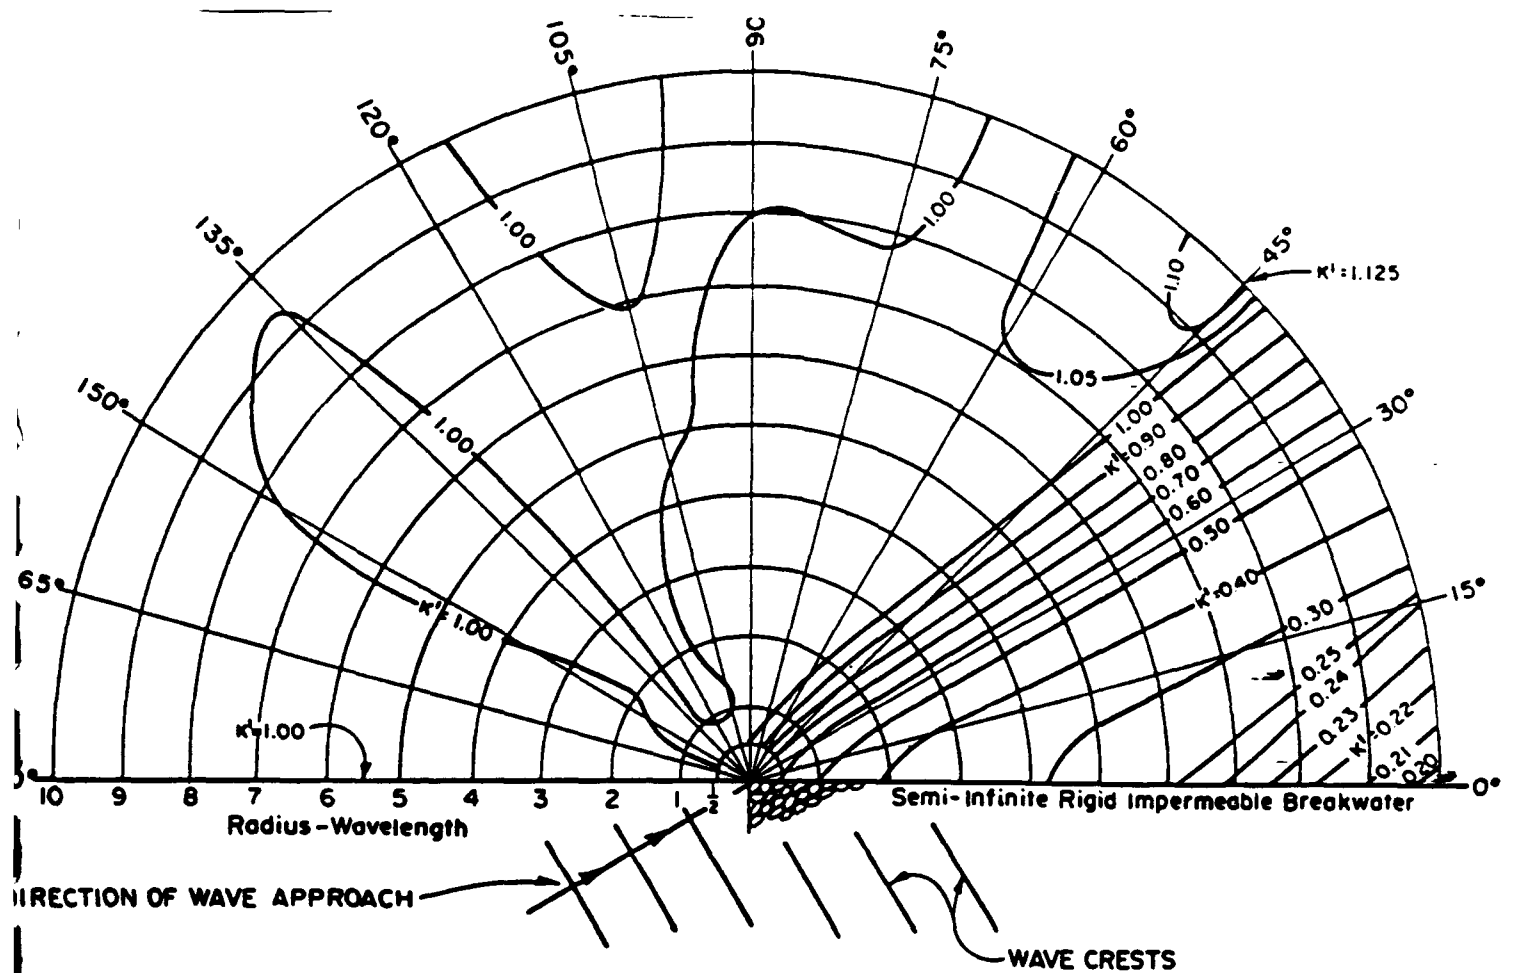
FIGURE (2) Representative Wave Diffraction Diagram [after Wiegell]

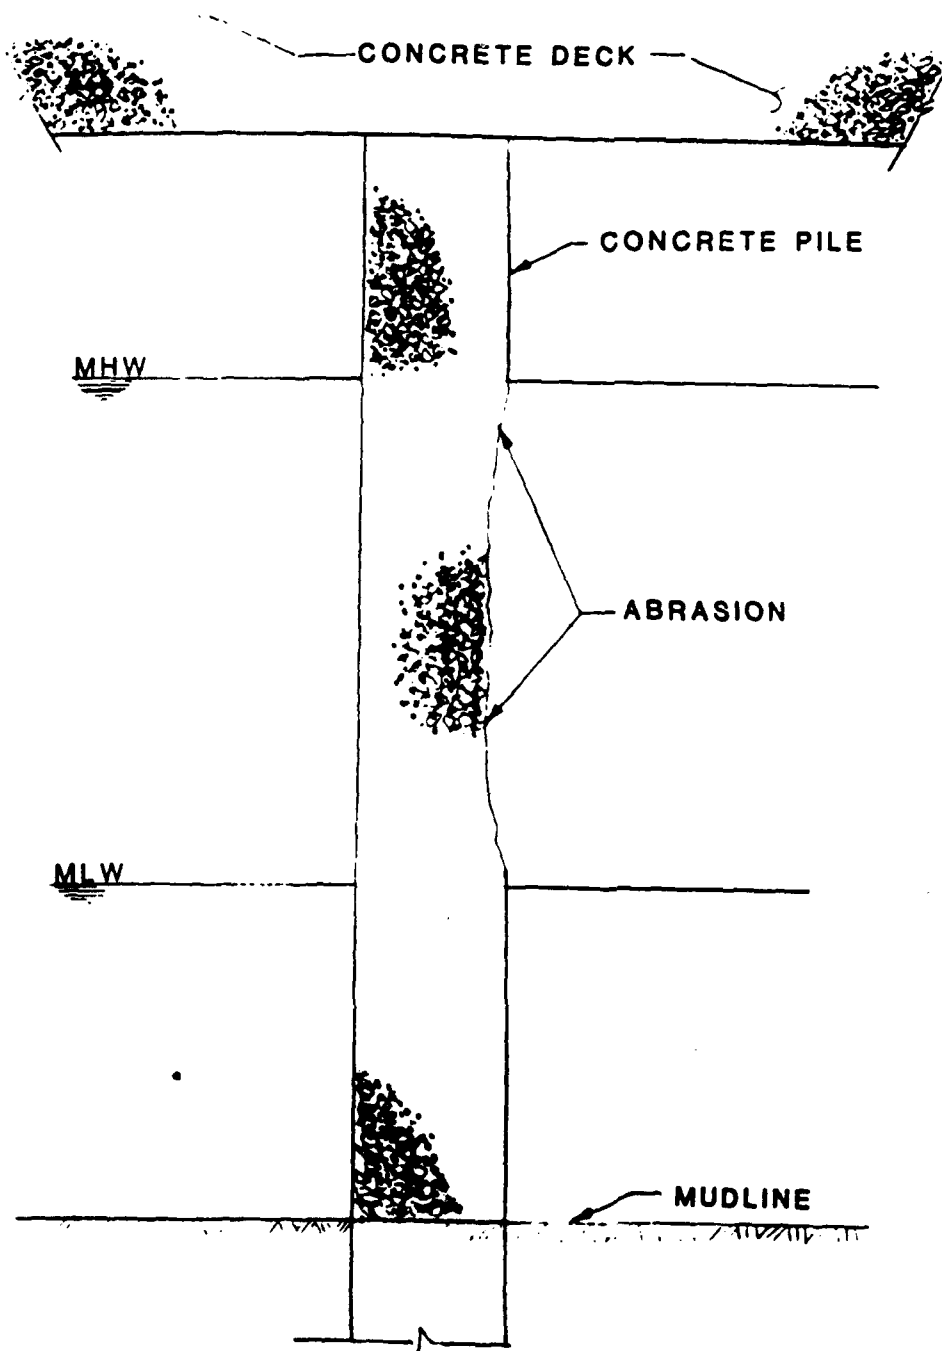
**FIGURE (3) Abraded Concrete Pile [After NCEL]**

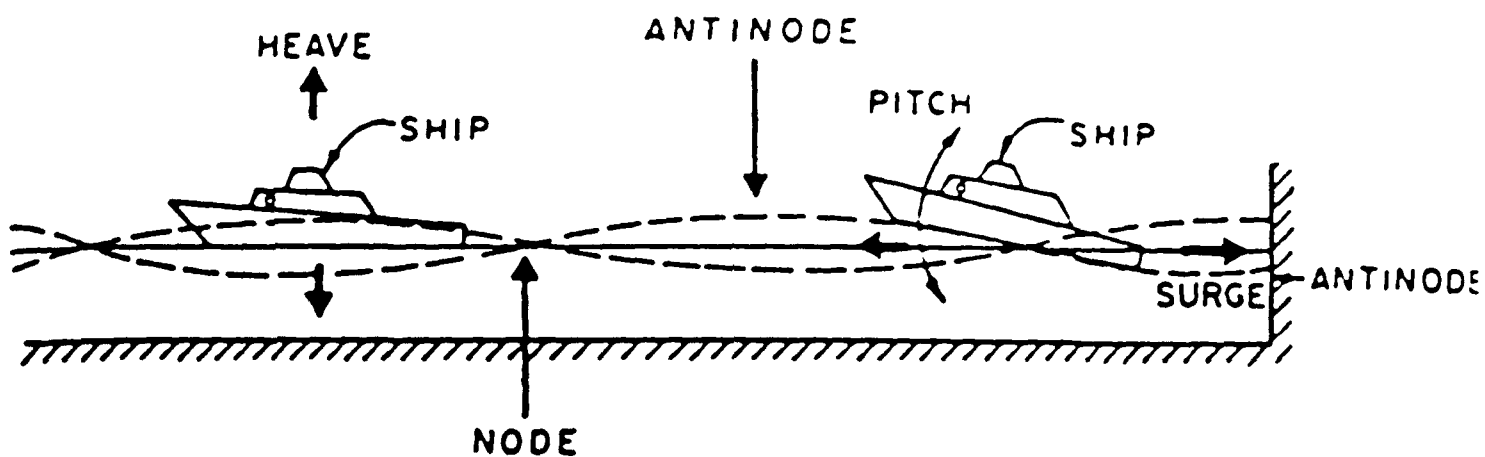
**FIGURE (4) Typical standing Wave System in A Harbor**  
[After DM 26.2]

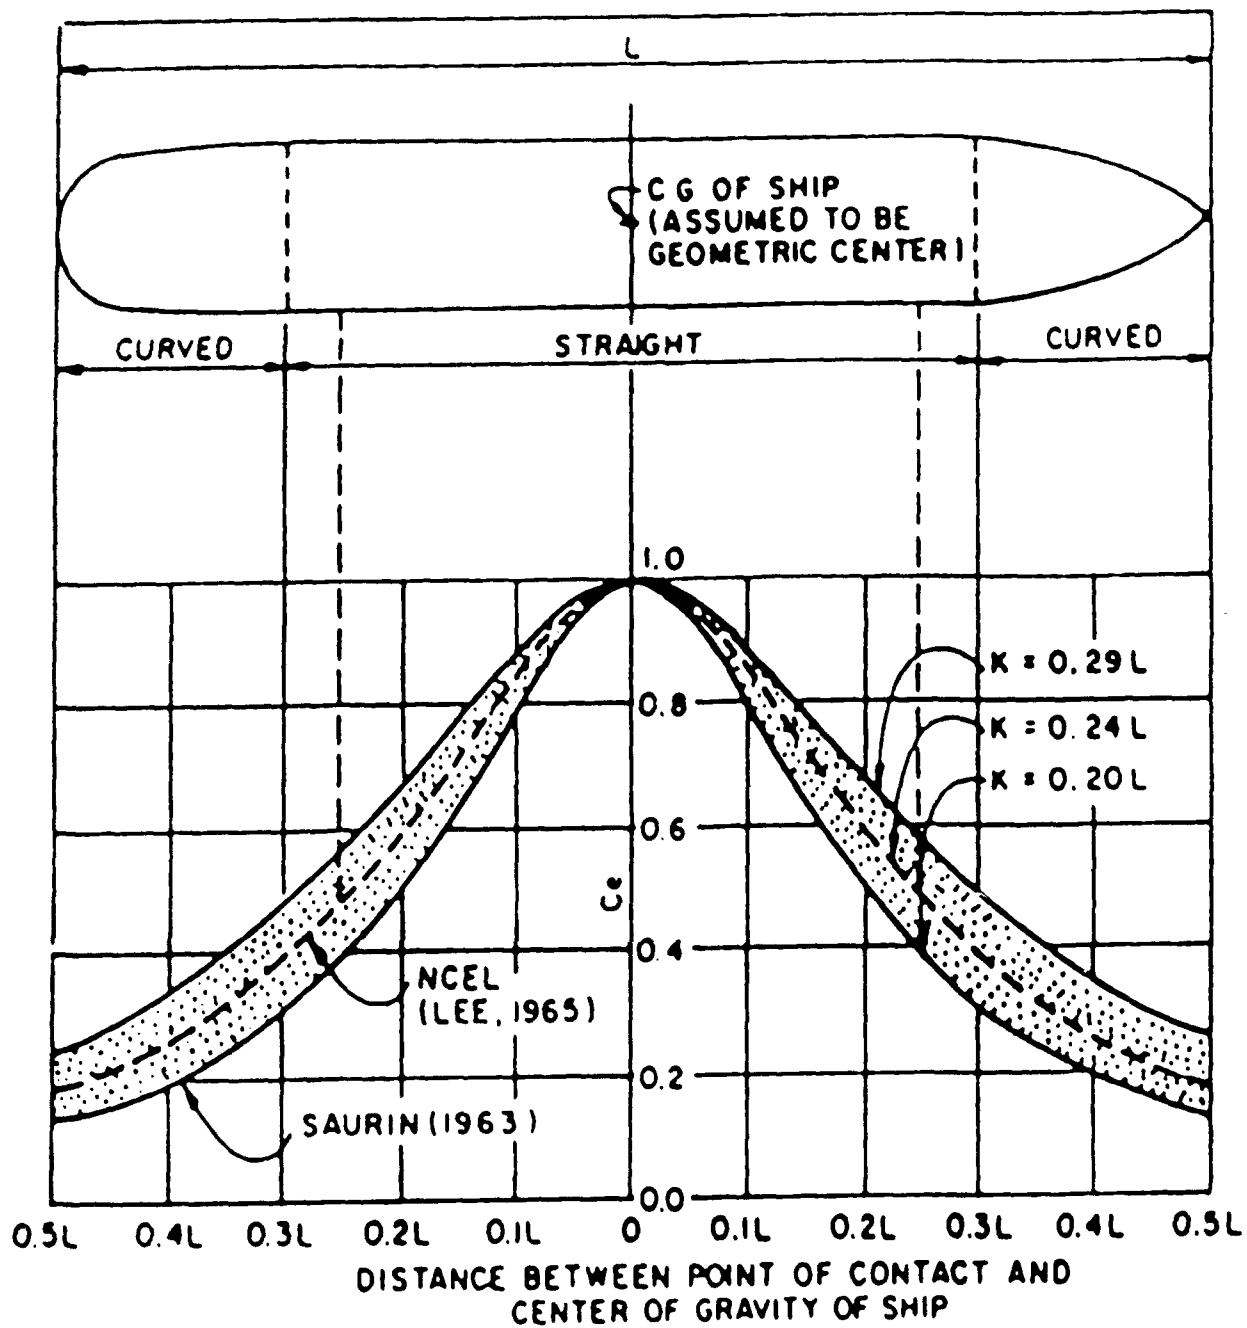
**FIGURE (6) Eccentricity Coefficient For Calculation of Docking Force [after DM 25.1]**

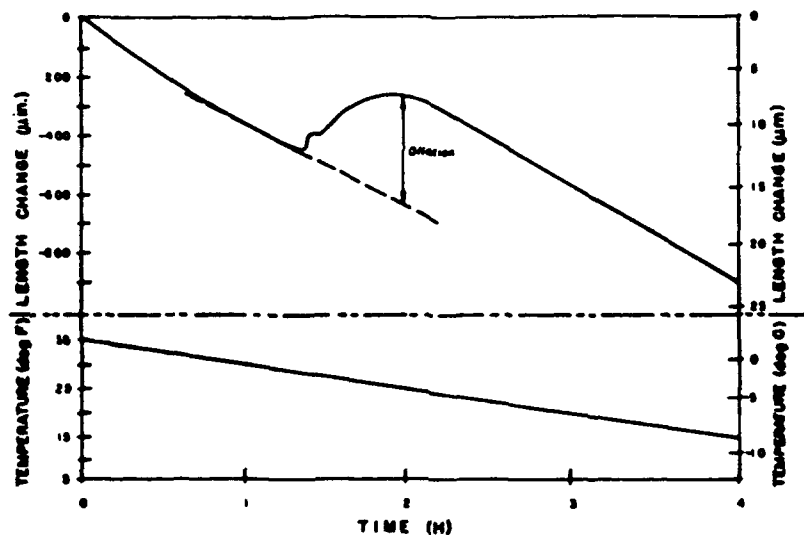
Fig. 1 - Typical Length Change and Temperature Charts for the Dilation Method.

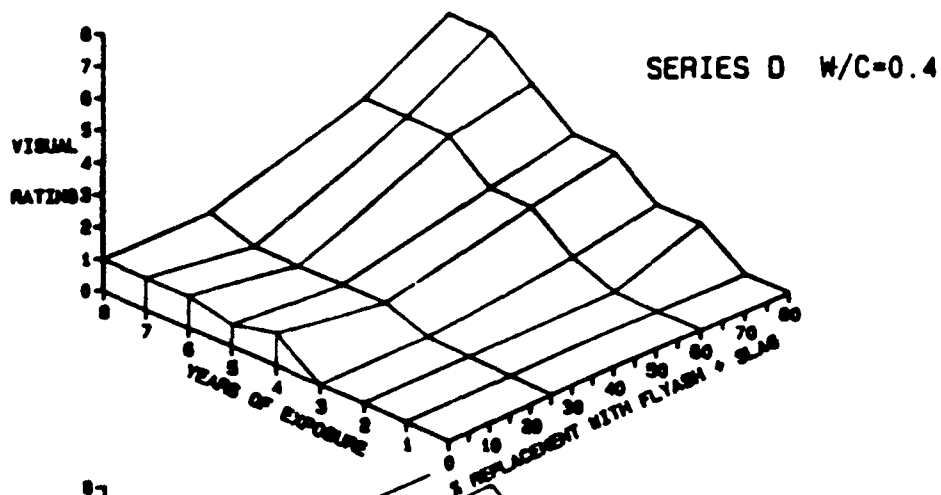
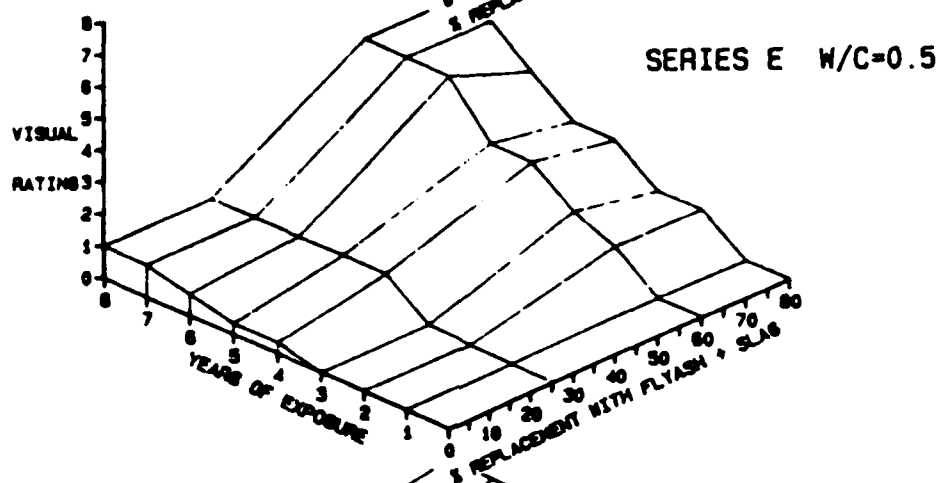
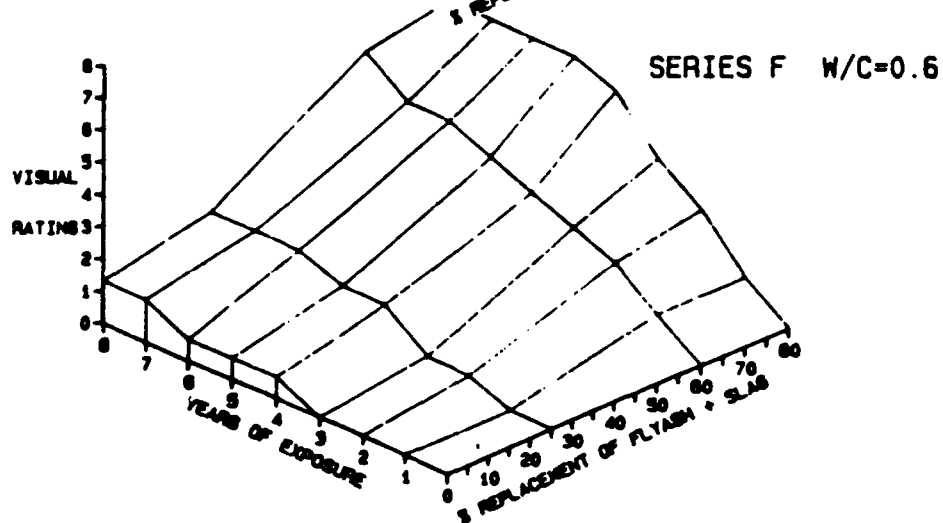
Fig. 4 - Visual Ratings as a Function of Both Fly Ash and Slag Content, and Time of Exposure (CANMET Investigations --Phase II).

Concrete incorporating high volumes of pelletized slag and fly ash perform relatively poorly. It appears that, for the combination of the materials used in this phase and for satisfactory performance under the exposure conditions at Treat Island, the air-entrained concrete must contain a minimum amount of cement, and this appears to be of the order of 200 to 250 kg/m<sup>3</sup> (Fig. 4).
